# Scanning Electron Microscopy (SEM)

## Caterpillar Engine Cam Shaft Sleeve Bearing Failure

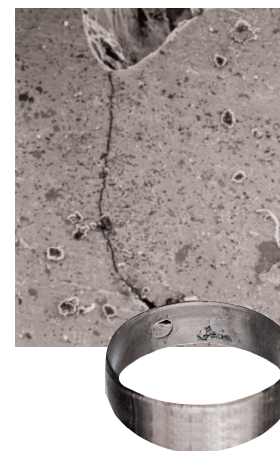
The camshaft sleeve bearings were found to be severely pitted. Large particles broke away and a costly failure occurred.

Cavitation erosion caused by the formation of oil vapour bubbles in low pressure areas and the collapse of those bubbles in higher pressure areas.

Confirmed that as the initial pitting and material removal continued due to cavitation erosion, larger scale pits/pores developed. This caused a deeper penetration of the vapour bubbles, which resulted in further fracture creation and propagation as well as the large scale removal of bearing material.

This type of failure can occur on diesel engine cam shaft sleeve bearings under high speed and/or high load conditions.

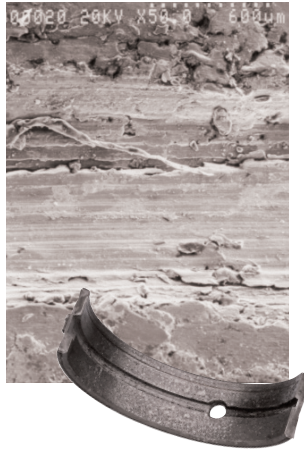
## Caterpillar Diesel Engine Bearing Failure

The crankshaft bearings were found to be in various states of abrasion.

Deep scoring and discoloration suggested that high levels of dirt had either severely scratched or become embedded into the soft overlay of the bearings.

Confirmed deep scoring on the bearing surface combined with foreign material embedded in the bearing surface at random locations. These foreign materials are irregular in shape and showed different colour variations in response to electron bombardment.

These colour variations indicated foreign material of different composition and type.

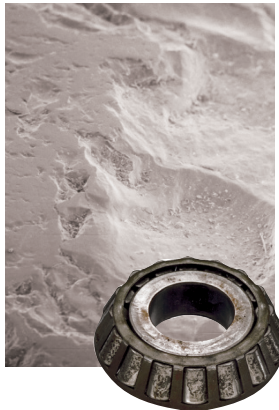
## Tapered Roller Bearing Failure, Final Drive Application

Discoloration and severe spalling of the bearing.

The condition suggested fatigue spalling with possible rust development. However, the oil analyzed for water content and results were negative.

Confirmed that the severe spalling of the bearing was not due to fatigue. This was evident by the rather smooth surfaces of the damaged areas. Normally, fatigue spalling causes sharp and/or jagged edges to the spalls.

The more smooth spalls that developed indicate the occurrence of strong acids which resulted from excessive water in the oil that had evaporated during a period of hot shutdown just prior to equipment storage. The bearing cones showed similar spalling conditions, though only on the inner race surfaces that were above the surface of the oil.

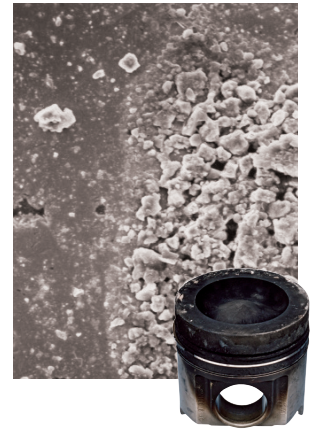
## Caterpillar Diesel Engine Piston, Ring and Liner Failure

The Piston failure resulted in a scored cylinder liner and ring sticking condition.

Confirmed large deposits of carbon and soot material. Further analysis of these carbon/soot deposits using X-ray Energy Spectroscopy showed the elements; iron, sodium, magnesium, phosphorus, sulphur, calcium and zinc. The high level of sulphur indicated unburned fuel and this supported an initial suspicion that a fuel leak had occurred, washing past the piston ring area. This condition accounted for the ring sticking and eventual piston failure.

Since the remaining elements are indicative of the normal additives found in diesel engine oils, there was no evidence that any foreign or incompatible after-market additives had been the cause of failure.
